FINAL REPORT  
ON  
DEVELOPMENT OF BASIC PROCESSING TECHNOLOGY  
FOR  
BEARING QUALITY SILICON NITRIDE BALLS

U.S. NAVY CONTRACT NO. N00019-76-C-0684  
SKF REPORT NO. AL77T057  
SKF CODE NO. LC398  
SKF REG. 414 2

RESEARCH LABORATORY  
**SKF INDUSTRIES, INC.**  
ENGINEERING AND RESEARCH CENTER  
KING OF PRUSSIA, PA.

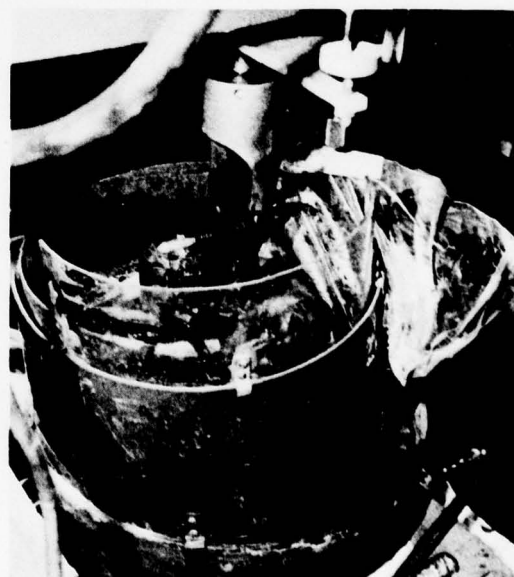
Figure 6. Ultrasonic Machining Set-Up for Ball Bearing Inner Ring

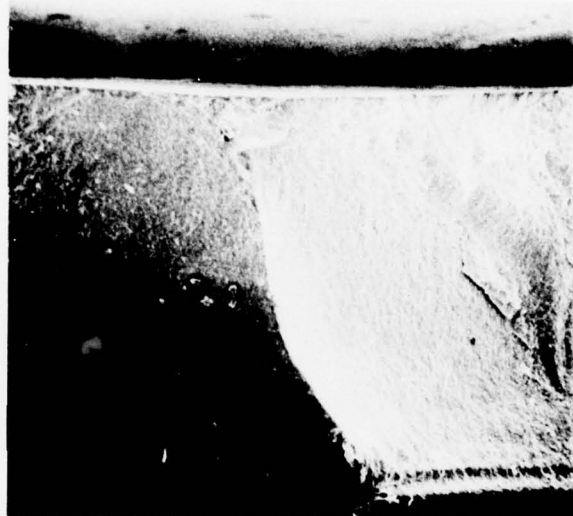
Figure 12. Fractograph of a Fractured NC132 Disc (0.99 GPa)  
Indicating Fracture Initiation at Residual  
Surface Scratches.

Fractographs made with a SEM are shown in Figures 10-12. Porosity is clearly responsible for fracture initiation in the GTE Sylvania sample. A high magnification view of the pore surface does not reveal unsintered silicon nitride grains, probably since they may have been dislodged in the fracture process. In the Ceradyne material a cluster of second phase particles (free Si) was responsible for fracture initiation. A high magnification view of the fracture surface shows presence of a large volume fraction of the second phase particles. Fracture initiation in the Norton material appears to have occurred at surface scratches. The degree of material cleanliness and absence of porosity explain the high strength value obtained for the Norton's NORALIDE NC132 grade silicon nitride.

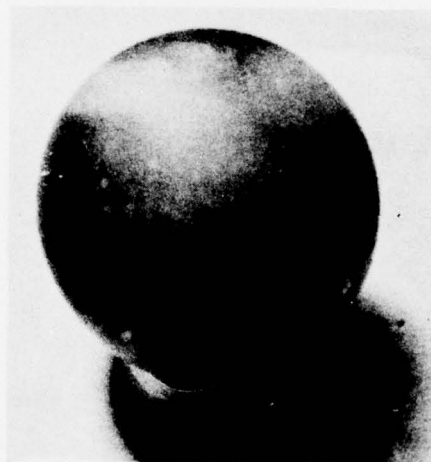
Figure 21. Photographs of Surfaces of (a) GTE Sylvania and (b) Norton Ball Produced by Krypton Exposure Technique. Dark (Exposed) Spots on the GTE Sylvania Ball are Indicative of Surface Porosity.

The sensitivity of KET is limited only by the grain size of the emulsion film, so that it can be expected that a maximum sensitivity of about 4  $\mu$ m will be obtained. For an initial evaluation of this technique one GTE Sylvania ball and one Norton finished ball were examined at QUAL-X, Inc. The GTE Sylvania ball, having a light color, was processed as is. The darker colored Norton ball was coated with  $TiO_2$  to improve the visibility of the exposed areas. This was necessary since it was found difficult to peel the emulsion off the ball surface for examination without disturbing or breaking it. The dark color of the ball made it difficult to see any dark exposed areas on the overlaying film.
